# The American Museum of Safety

Mr A A Anderson Chairman  
The Mayor's Central Committee on  
Street Traffic and Safety  
City of New York

Some Sidewalk and Street Accidents  
Other Than Vehicular

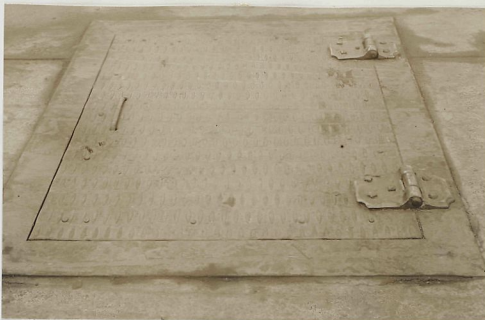
Cellar door or coal-hole cover, cover-hinges should be on the underside to avoid tripping. Diamond steel plate is frequently very slippery.

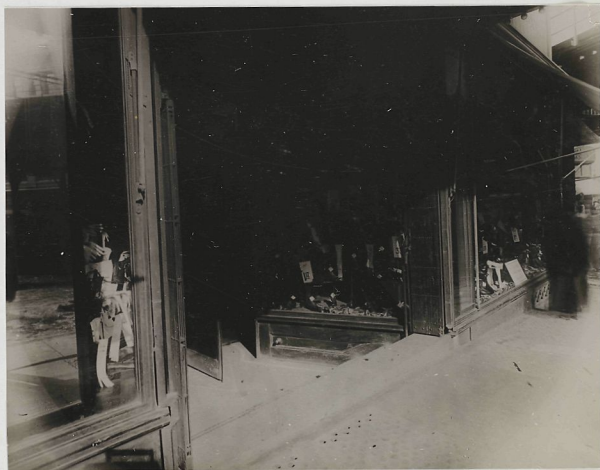
The scene of a fatality. A woman coming out of the store slipped on the steel plate or glass vault lights in the sidewalk, struck her head on the stone sill and died soon afterward.

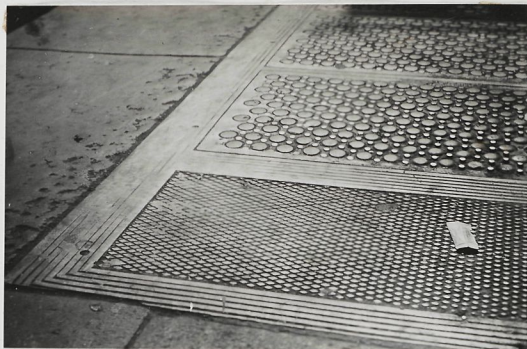
Metal frames or borders around sidewalk lights are very common and exceedingly dangerous.

All surfaces where people walk should be so constructed and maintained that slipping on them is impossible. Corrugations or other irregularities of metallic surfaces do not make them slip-proof. Borders of iron around sidewalk lights, steel and iron coal-hole covers, metal curb edgings and other surfaces usually metallic, should not be employed unless there is embodied in the metal some abrasive that will render it slip-proof.

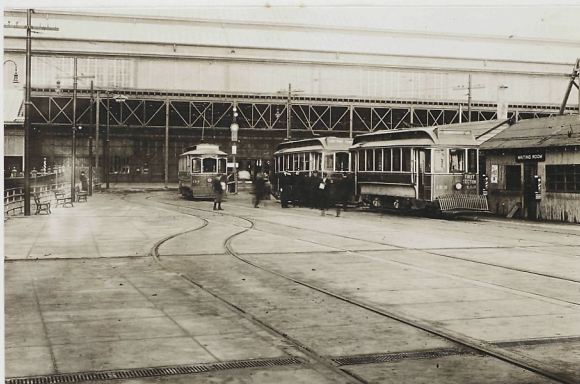
Slip-proof drainage gratings and expansion joint cover plates in the concourse of the St George Ferry Terminal  
(Built by the City)

The New York City Department of Docks and Ferries in the new Terminal at St George, Staten Island, used over a thousand feet of slip-proof drainage gratings and expansion joint cover plates to provide safe footing for the many people walking over the concourse. In this case, the material used was cast iron with a wearing surface embodying alundum grit in such a way that it is absolutely slip-proof and extremely durable.

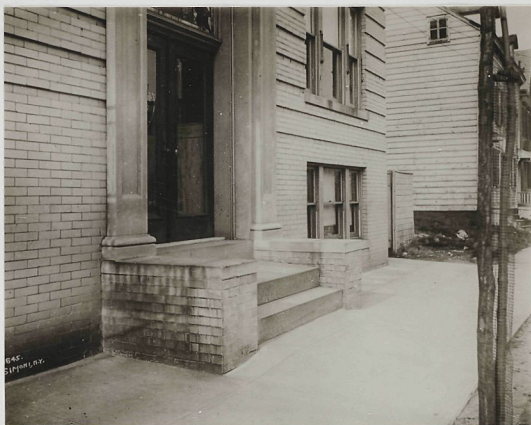
Here a man coming out of the building slipped on the slight incline in the sidewalk and falling backward crushed his head on the sharp edge of the blue-stone steps. Death was almost instant.

Granolithic or cement surfaces where there is a grade or ramp are the source of many accidents. Frequently some good abrasive such as carborundum or alundum is trowelled into the cement or occasionally used as a part of the mix. This is considered by some to give good results. No definite conclusion has been reached. However, it appears from observation that when the surface is dry, nothing special is needed; but if wet it is not made slip-proof by this provision. Crosses or narrow strips of abrasive-metal or other proven slip-proof material should be required at such places.

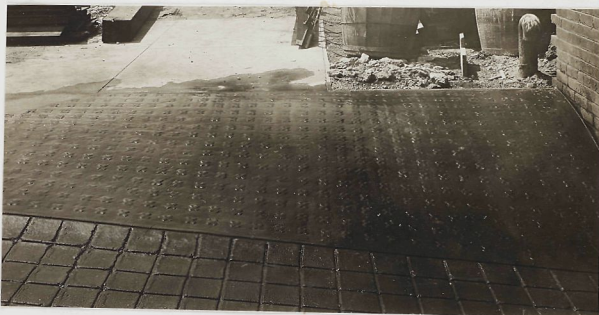
The Brooklyn Edison Company used crosses of slip-proof material set in the cement surface of the sidewalk where it sloped considerably to make a cut for driveway.

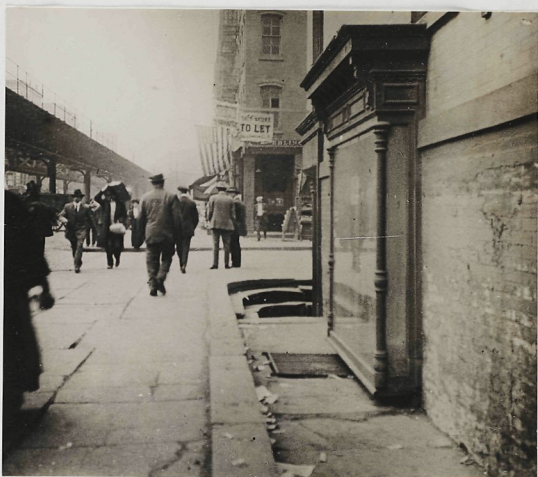
Many people are severely injured by falling into unguarded areas-ways.

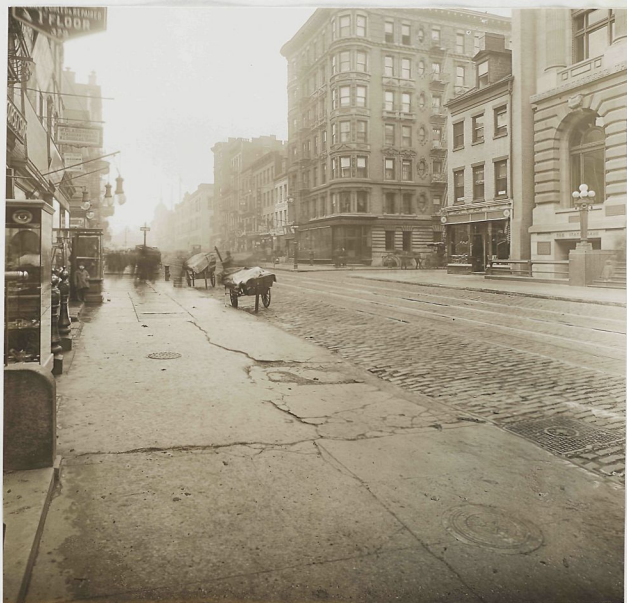
Holes in sidewalks due to the breaking away of concrete are frequently found. Such conditions are bound to occur, but what makes this matter worthy of attention is that they are not promptly repaired. One particularly bad place on a busy street in the down-town section of New York has been tripping and throwing scores of persons daily for nearly a year. Though the condition of this sidewalk is not bad as they go in New York, nevertheless it gained a verdict and substantial award for the man that broke his ankle.

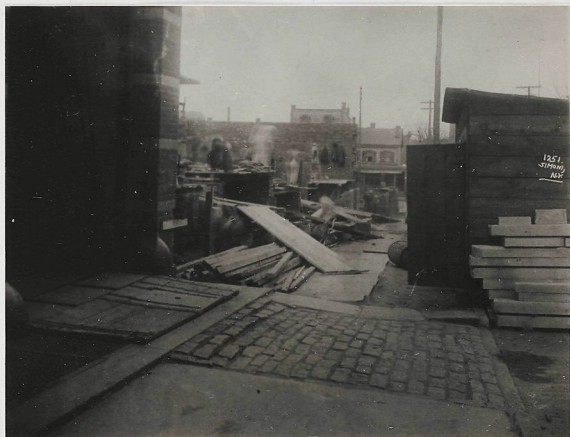
Scene of another accident for which plaintiff received substantial award. Sidewalk obstructions, especially around new building operations, should be prohibited.

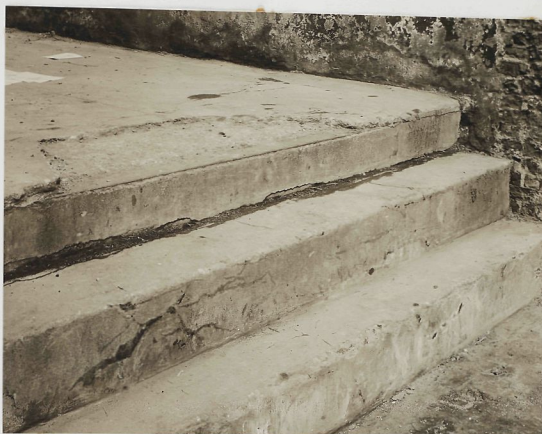
Cement steps if trowelled hard are slippery - if not trowelled hard they granulate - and regardless of how they are trowelled they chip off at the edges. A slip-proof tread will overcome the troubles and make the steps safe.

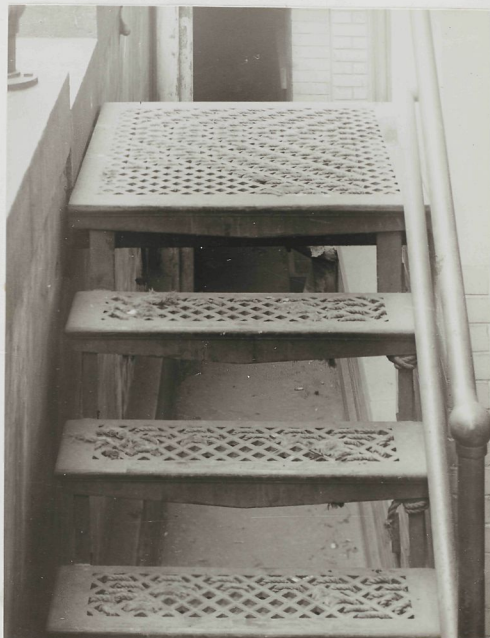
Cast iron and steel treads are unsafe because they are slippery. Here an attempt was made to overcome the slipping hazard by weaving rope through perforations.

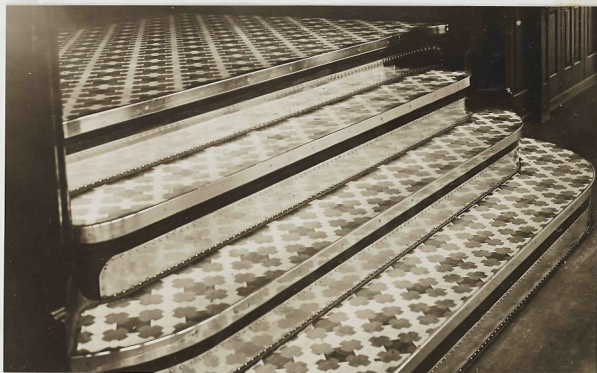
A smooth metal strip along the nosing of a step is dangerous. Many accidents are occurring on stairs as shown in the Municipal Ferry Boats.

It has been proven that a smooth steel or brass nosing strip is dangerous. For instance, from a safety standpoint, there is no objection to rubber on a stair tread if it is carried down over the nosing edge; but there is a decided hazard in the brass or steel nosing strip frequently used in connection with such treads. When the inevitable slip on such a nosing occurs, as a person goes down stairs, the foot slides forward and the front edge of the heel catches in the little offset formed by the rubber having worn faster than the metal nosing. As the heel catches, the foot is stopped; but the forward motion of the upper part of the body continues so that the person is thrown forward, usually striking on his head. This is the reason so many stair accidents result fatally by concussion of the brain.

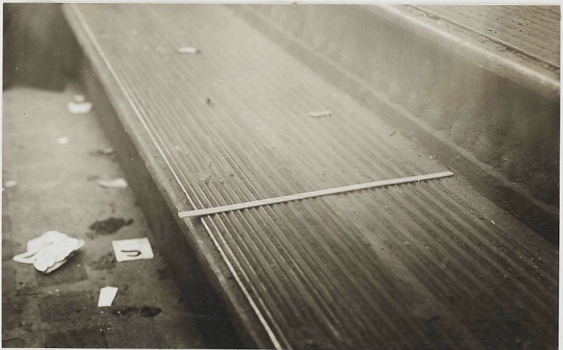
This type of tread caused 21 accidents in six weeks on one stair - owing to the combination of slippery nosing edge and heel-catching grooves. After the stair was equipped with safe treads, there were no accidents on it in three months.

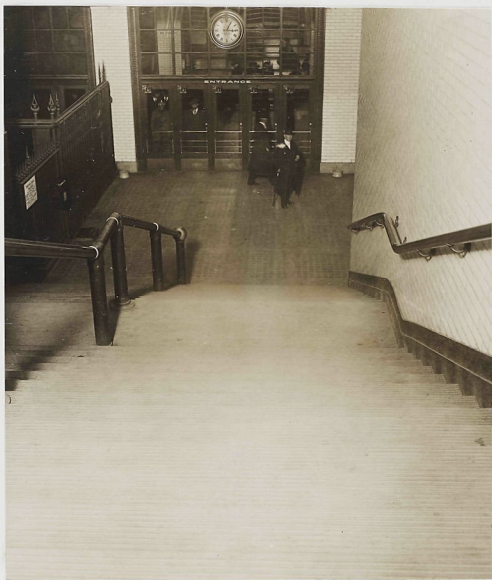
When looking down steps covered with grooved treads it is difficult to distinguish which one of the lines running in the same direction is the line of the edge of the step.

Many stair treads have a series of grooves back of and parallel to a slippery metal contact along the nosing edge. On such treads, people not only slip on the edge, catch their heels and sometimes toes with fatal results, but also find it difficult when going down to distinguish which one of the lines, all running in the same direction, is the line of the edge of the step. If the light is bad or eyesight poor this hazard is very great.

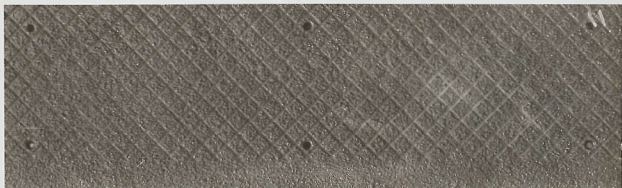
A good slip-proof material used especially for stair treads, but obtainable in any form desired, is made of iron and aluminum cast in it in such a manner as to prevent slipping.
